Setup: The jumper I normally have in place that connects TMAXPU to TMAx on the PDP11V2 card is removed – thus the card cannot actually request to be a bus master.

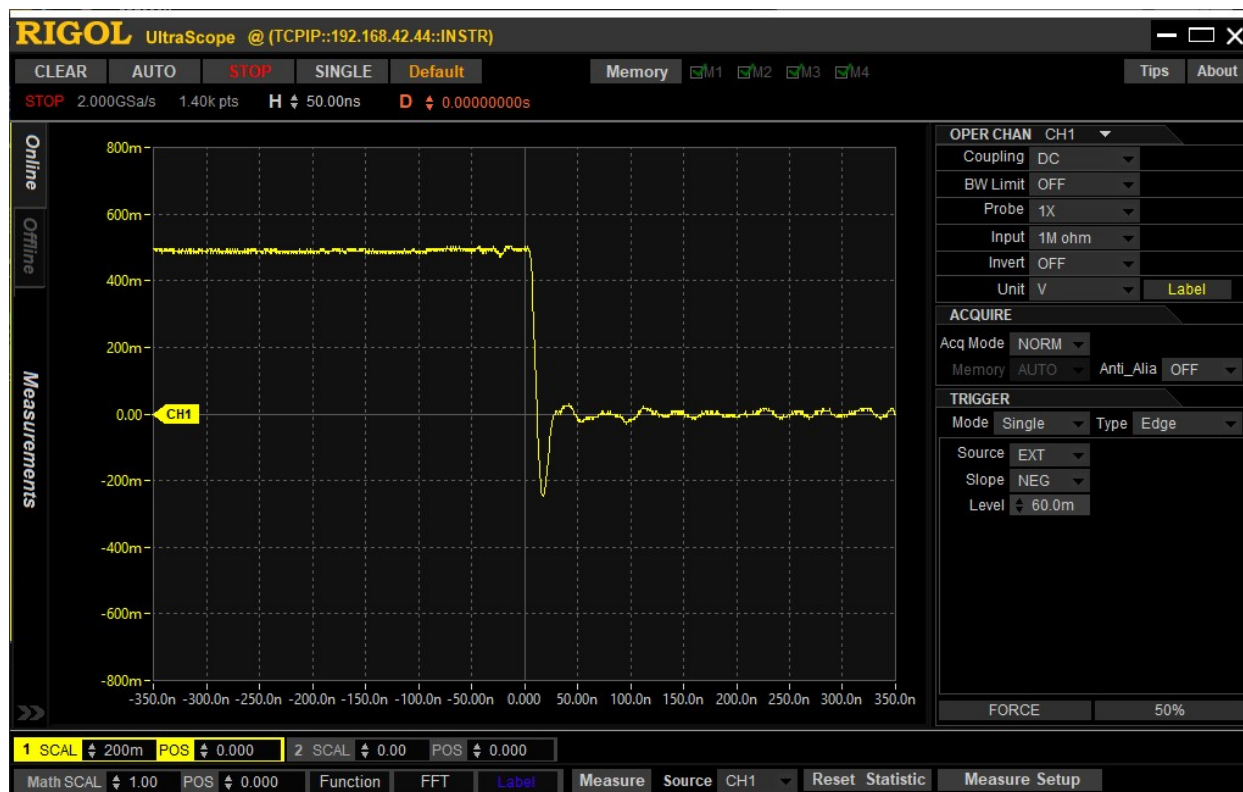
First, here is a screen shot of the TMAXPU signal going active (low) out of U25. (This signal should NOT have gone low – the machine was simply sitting in the console input poll loop). The trigger is the same signal, but connected to the external trigger input on the 'scope. (Generally in all of the traces, if the Trigger Source is EXT, it is connected to TMAXPU).

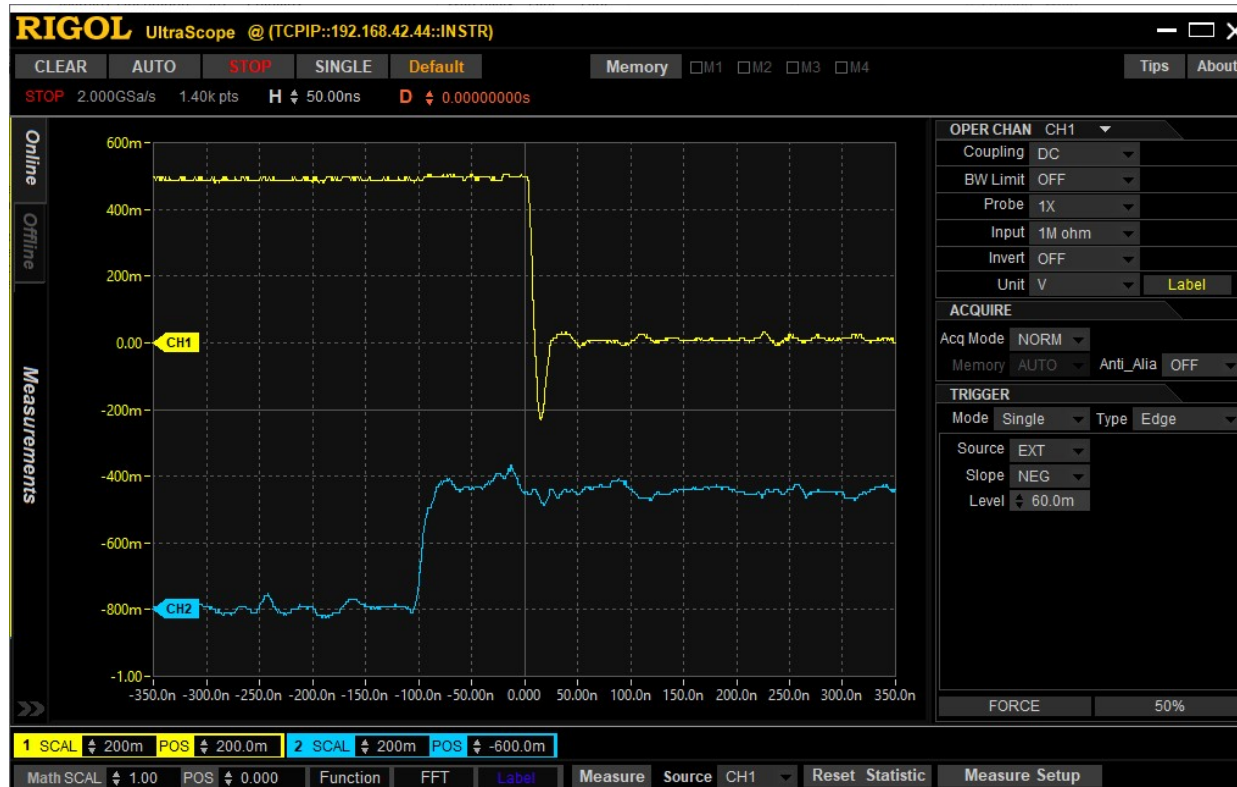
Next, I add signal pDBIN on channel 2 (pin 78 - the general read strobe) on channel 2. Channel 1 is still TMAXPU and the external trigger is negative going on TMAXPU, as before. We can see that pDBIN goes active 100ns before TMAXPU:

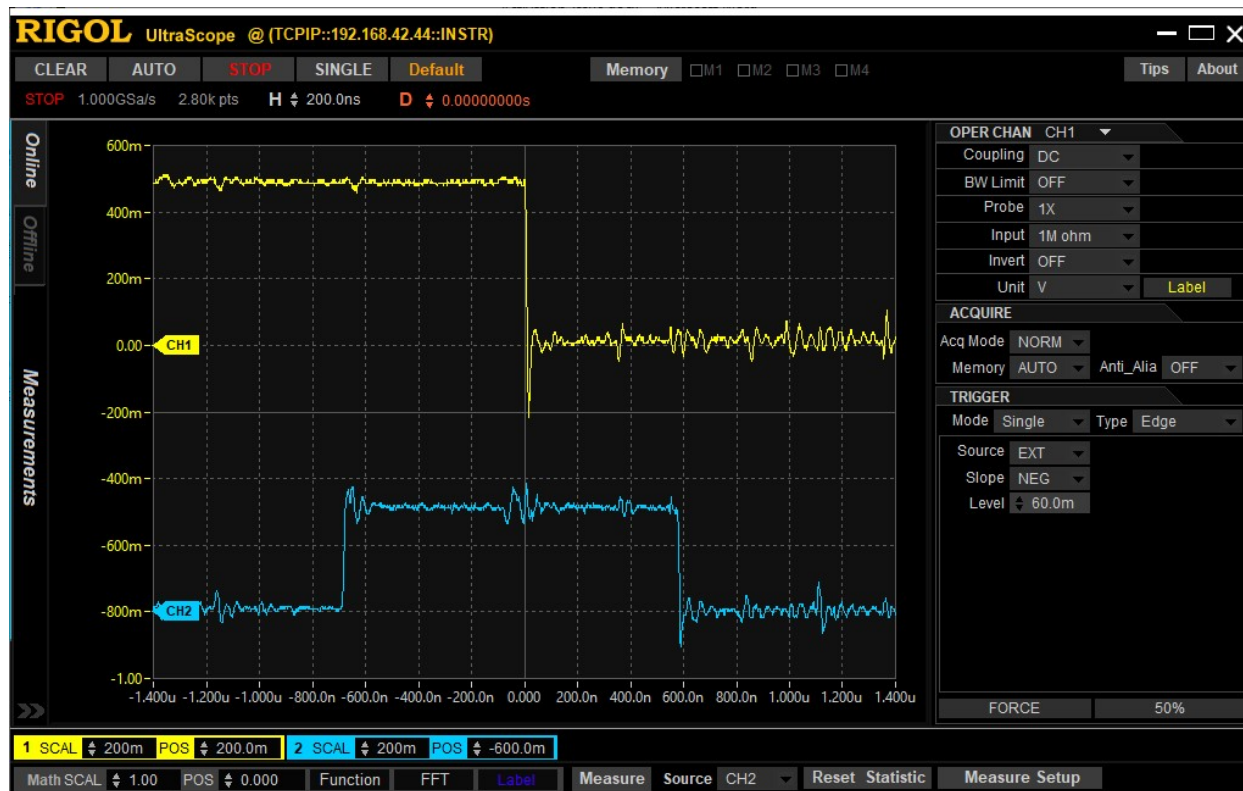
Next, I replace pDBIN with sINP. It is high – indicating an input I/O operation, as expected. I also lengthened the timebase to provide more context – but the trigger point is unchanged. So, sINP goes active about 700ns before TMAXPU, and pDBIN went active about 100ns before as well.

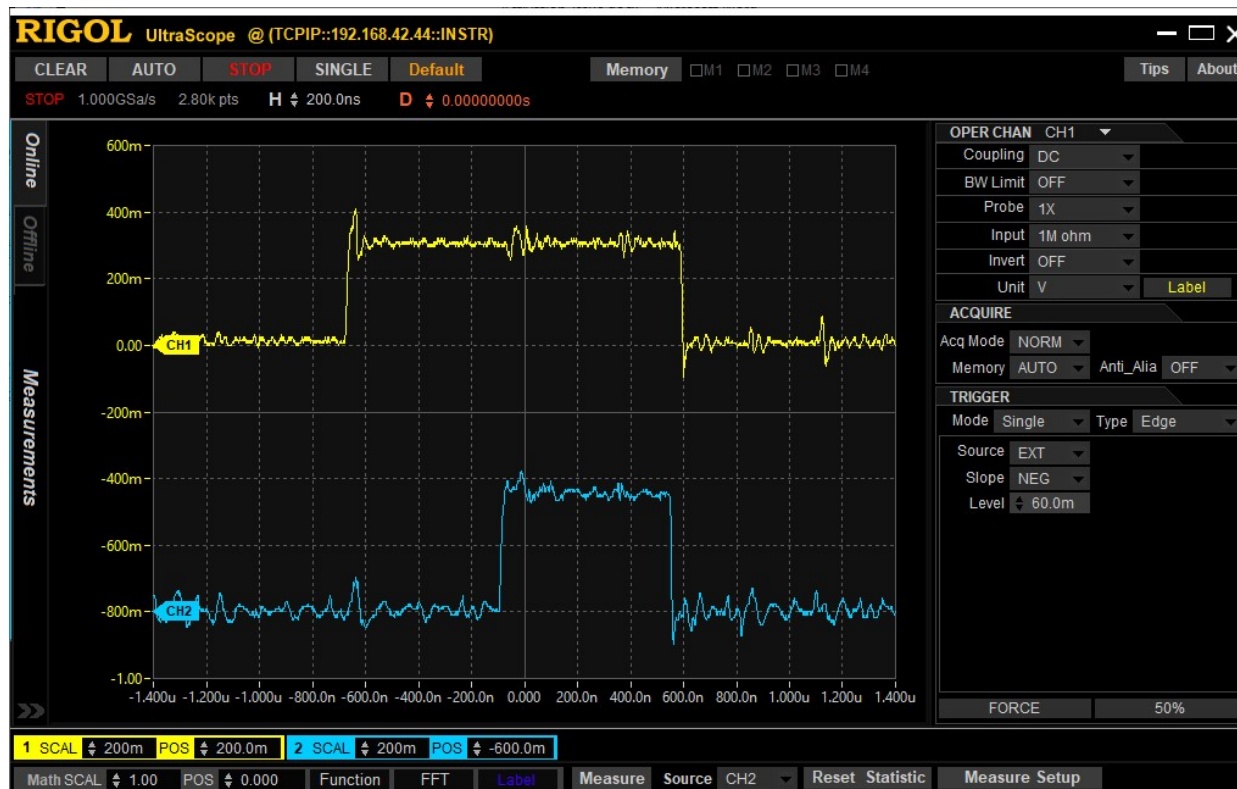
So next, I put up both sINP (bottom) and pDBIN (top) to show that relationship. The external trigger is still TMAXPU. Multiple captures demonstrated that TMAXPU is only triggering on an I/O operation (the console input loop, though sometimes it happens during the status polling for displaying the monitor sign-on message).

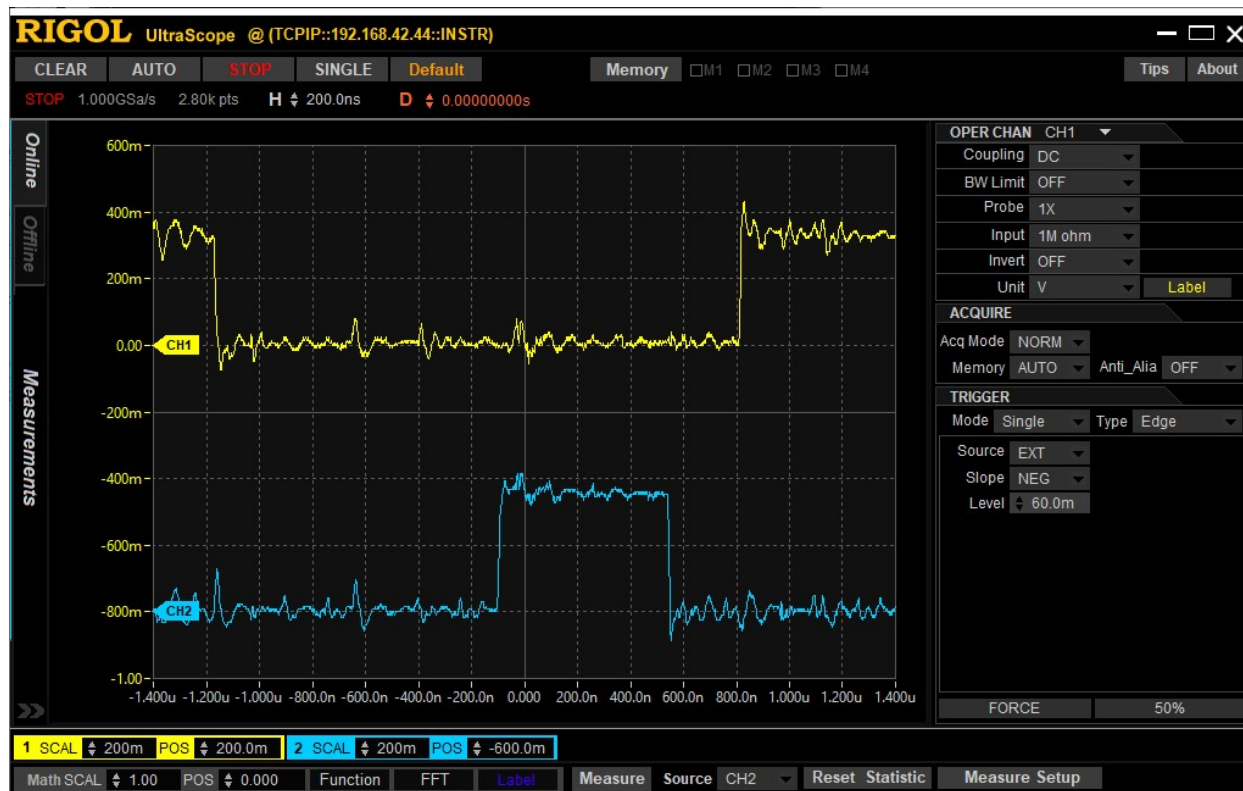
Since sINP is the later signal, I left that in place on channel 2, and picked an address line (A3) that it supposed to need to be a '1' in U25. The trigger is TMAXPU. The logic equation I use is this (because I have my Z80 set to mirror I/O addresses, I am only looking at the least significant 8 bits for 0xED):

WTF? A3 is NOT really a 1. But it is marginally close to 0.80v (x10 attenuation on the probe) to be in “no man’s land” for logic levels. A3 is driven on the Cromemco ZPU by IC25, a 74367 (as are most of the bus lines), and appears on the PDP11V2 card at U30 pin 12, a 75LS244 (U30 - soldered in place underneath the J11). I tried swapping 74367’s and even swapping in an 8T97 – no difference. It is also worth noting that these blips in A3 are happening every 200 to 400 ns.

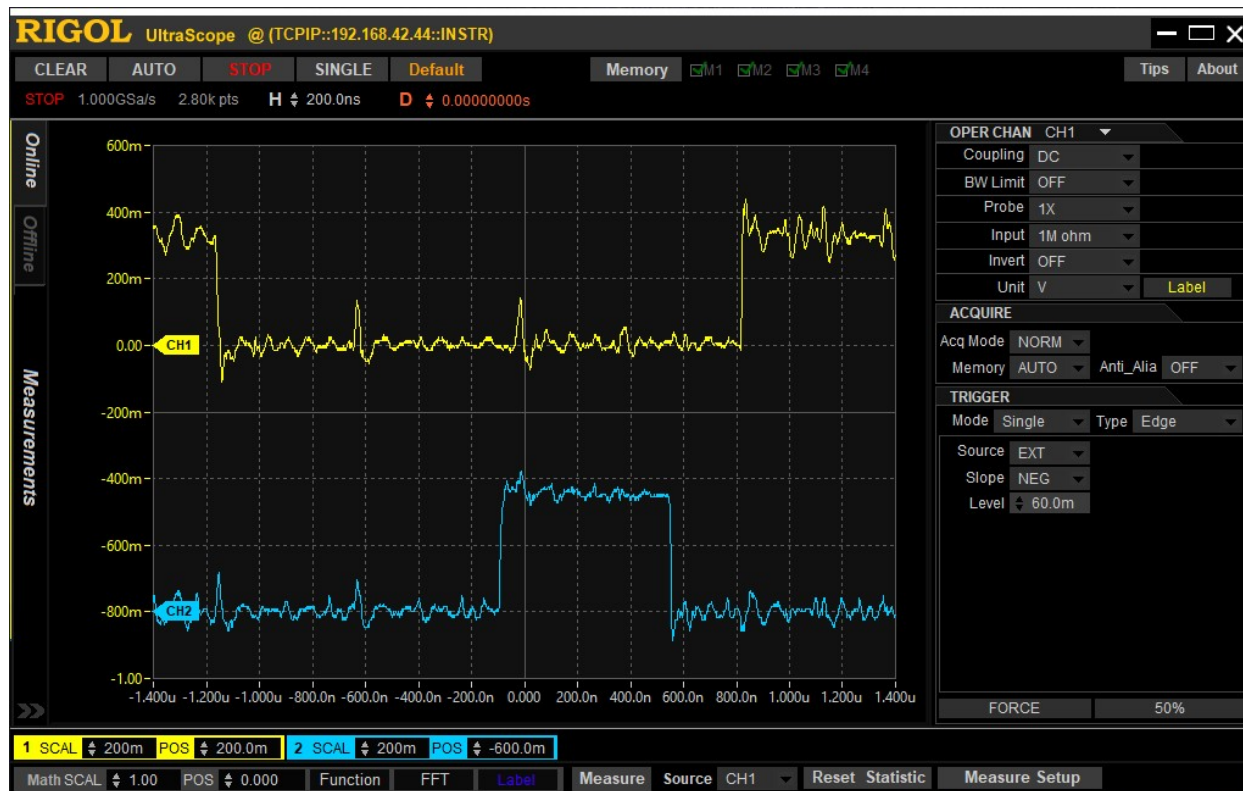
Next was to look at the 74LS244. This is the same A3 signal, but taken at the 74LS244 instead of at the bus connector, triggered by TMAXPU. This signal is even more into the “gray area”, which is interesting – that this noise is actually greater on the board than coming onto the board, which may explain why shielding helped – it would have added some capacitance and that may have tamped it down some.

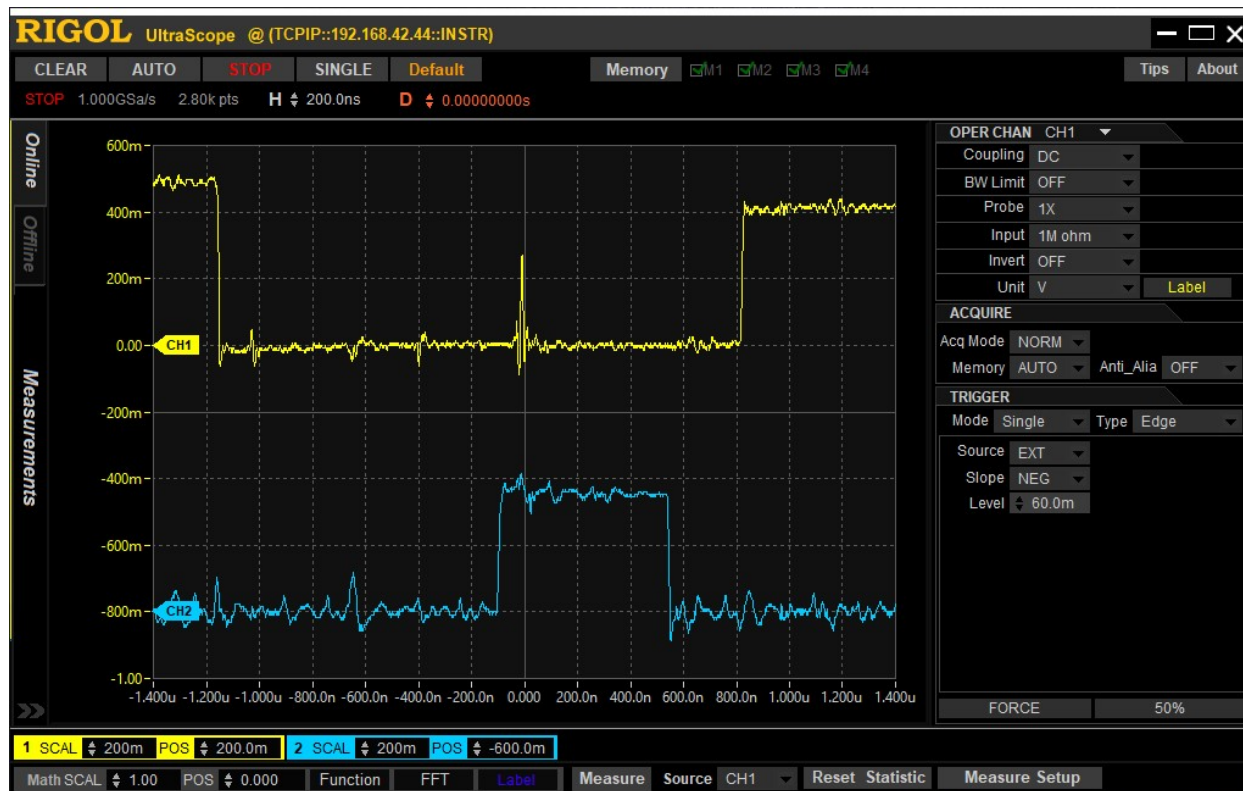
And here is A3 at the output of the 74LS244, triggered on TMAXPU, which shows a clear brief “glitch” on A3 in TTL “no man’s land” that is enough for the CPLD to treat it as a 1. So, the closer I get to the CPLD input, the worse it looks.

Note that this signal on A3 is not simply ringing – it is occurring when the signal is at 0 for an eternity (a full microsecond) before the problem. This is why adding termination did not help at all. It is happening roughly 100ns after pDBIN goes active, when nothing ought to really be going on anywhere.

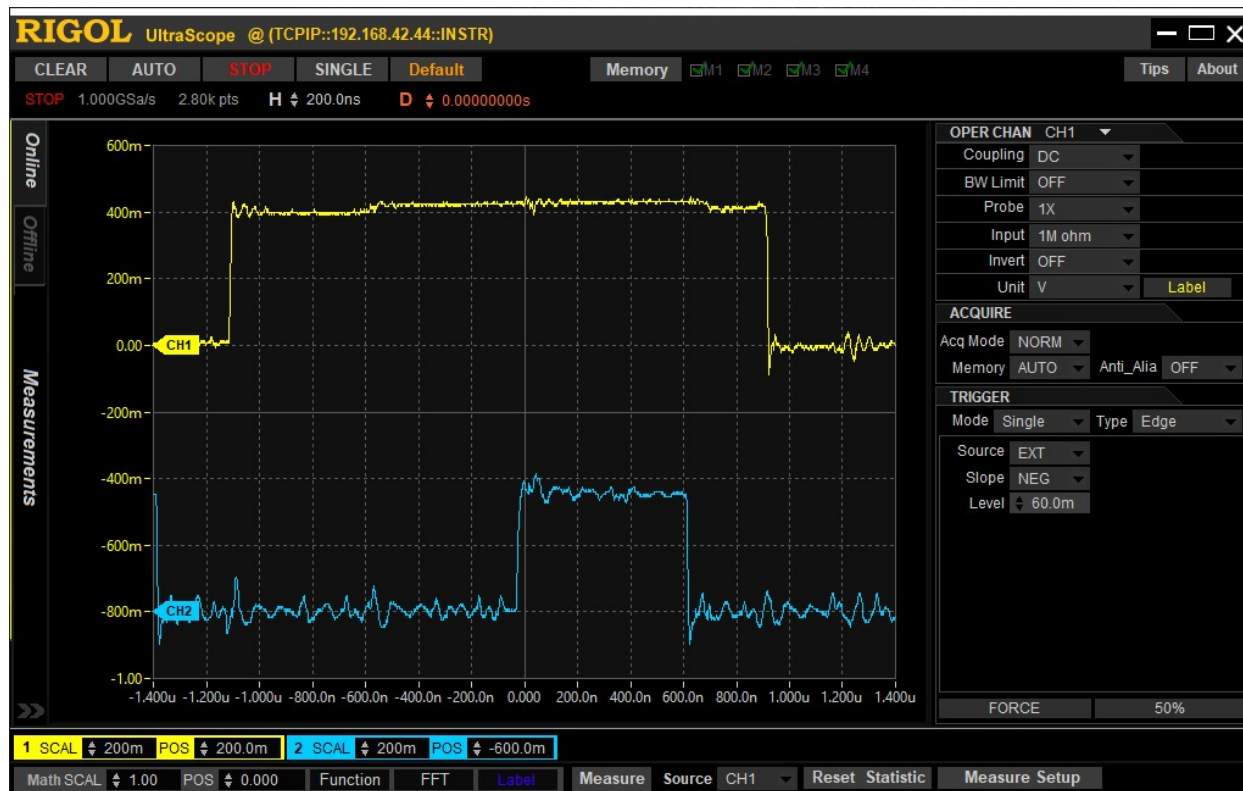
And here is what it really ought to look like – with the address line going high well before the pDBIN signal goes active, rather than after. This was done with the J11 chip removed – in that configuration TMAPXPU never activates TMAXPU unless I use the O or W command. (This one is on the input of the 74LS244 U30, rather than the output. The top signal is A3. Trigger is TMAXPU).

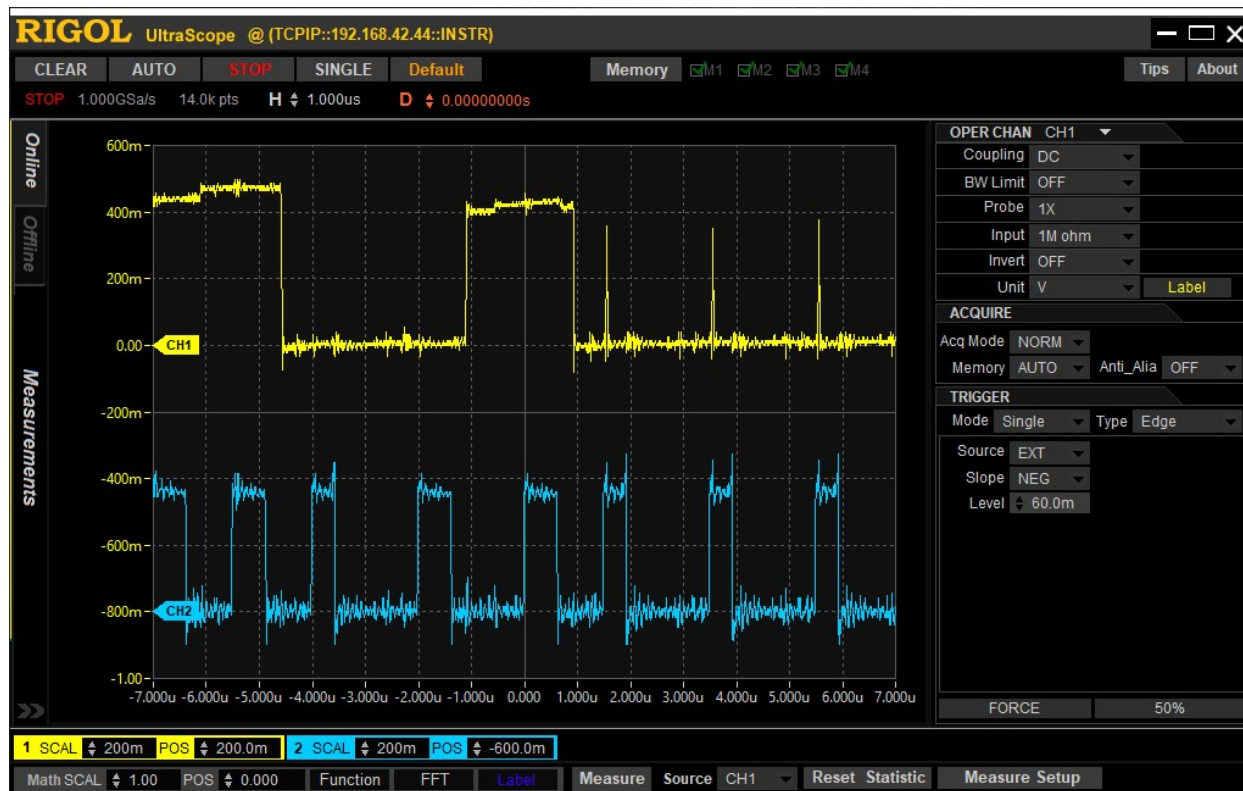
Here is the same sequence, but with a longer timebase (again the J11 is removed). It shows A3 at the 74LS244 output spiking during some, but not all, pDBIN cycles – and, if one looks carefully, it is always about 80-100ns after pDBIN goes active (yes, it is hard to see at this scale). The trigger was the same (TMAXPU), but in this case that was manually generated by command.

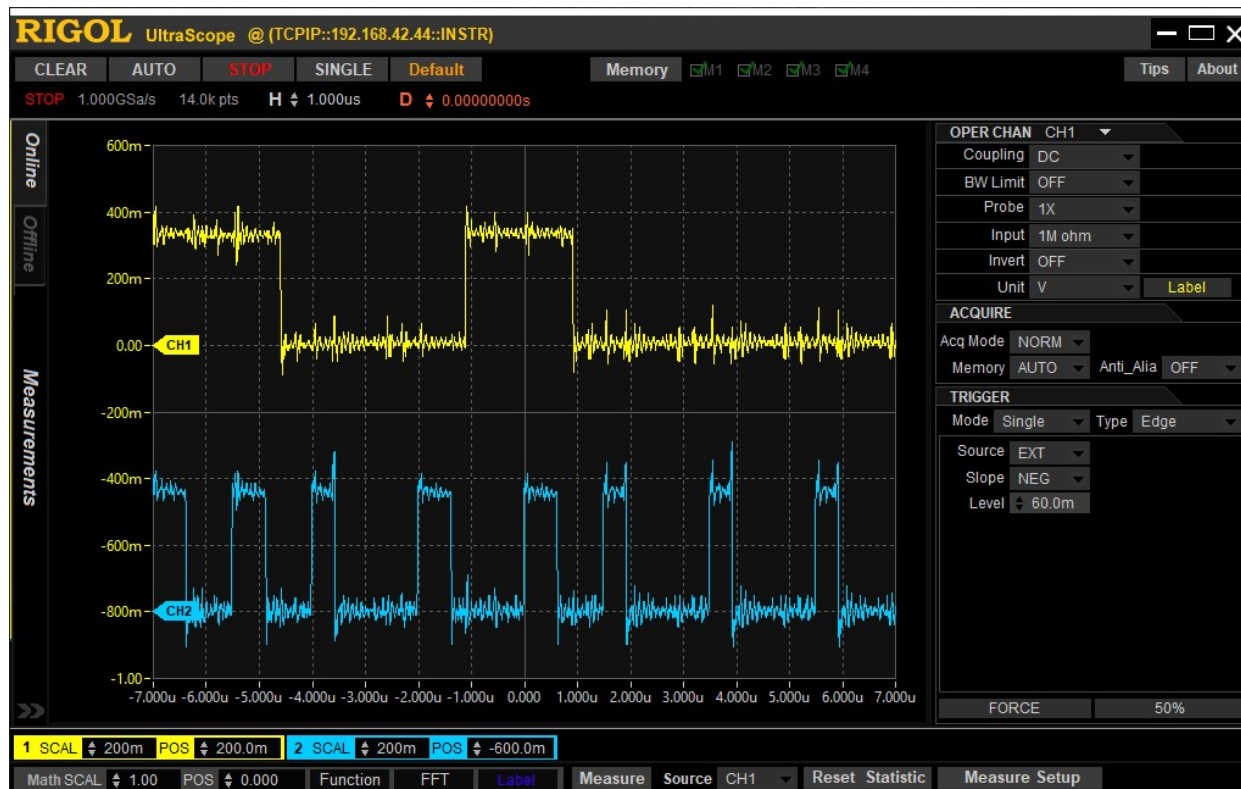
And here is the same sequence, but at the bus connector instead of at the output of the 74LS244 U30.

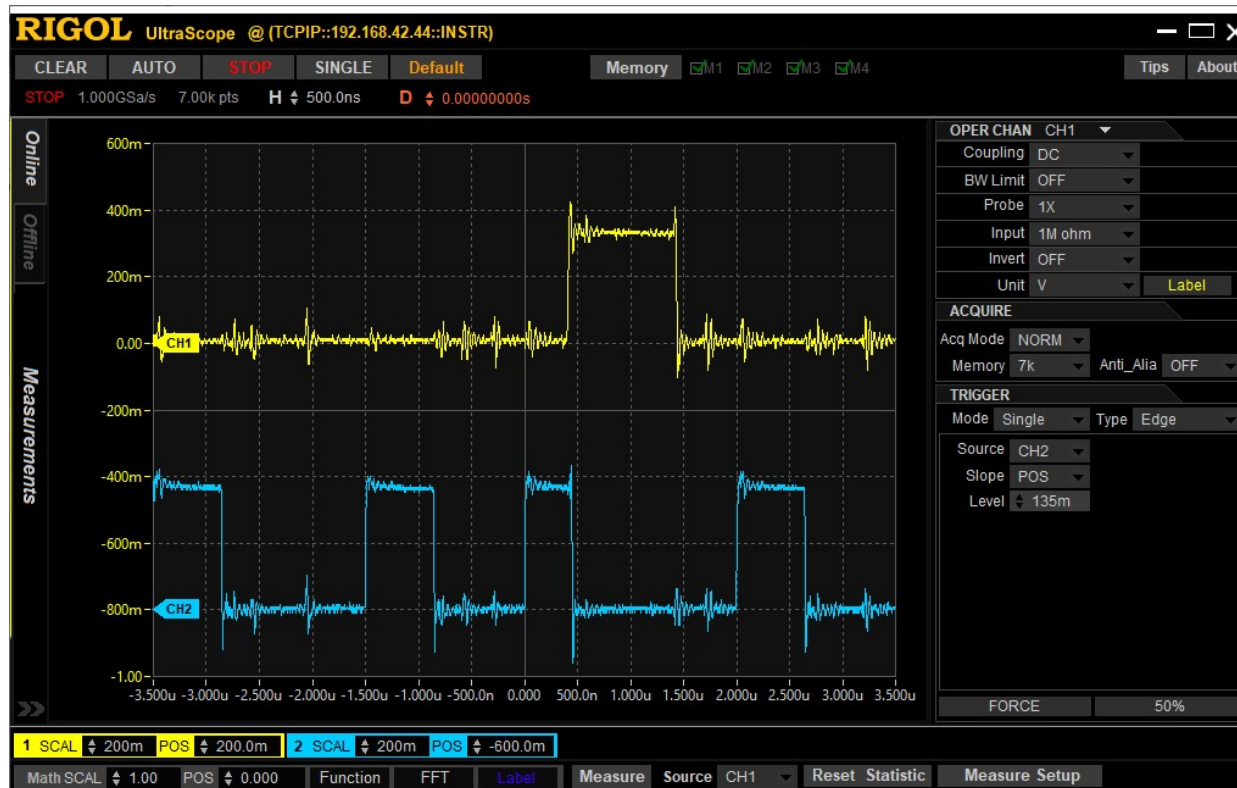
Here is a *typical* console input loop waveform (triggered on pDBIN) using the ZPU without the PDP11V2 board. As before, CH1 is A3, CH2 is pDBIN (which is also the trigger). This one was taken at 2MHz, as were the earlier waveforms:

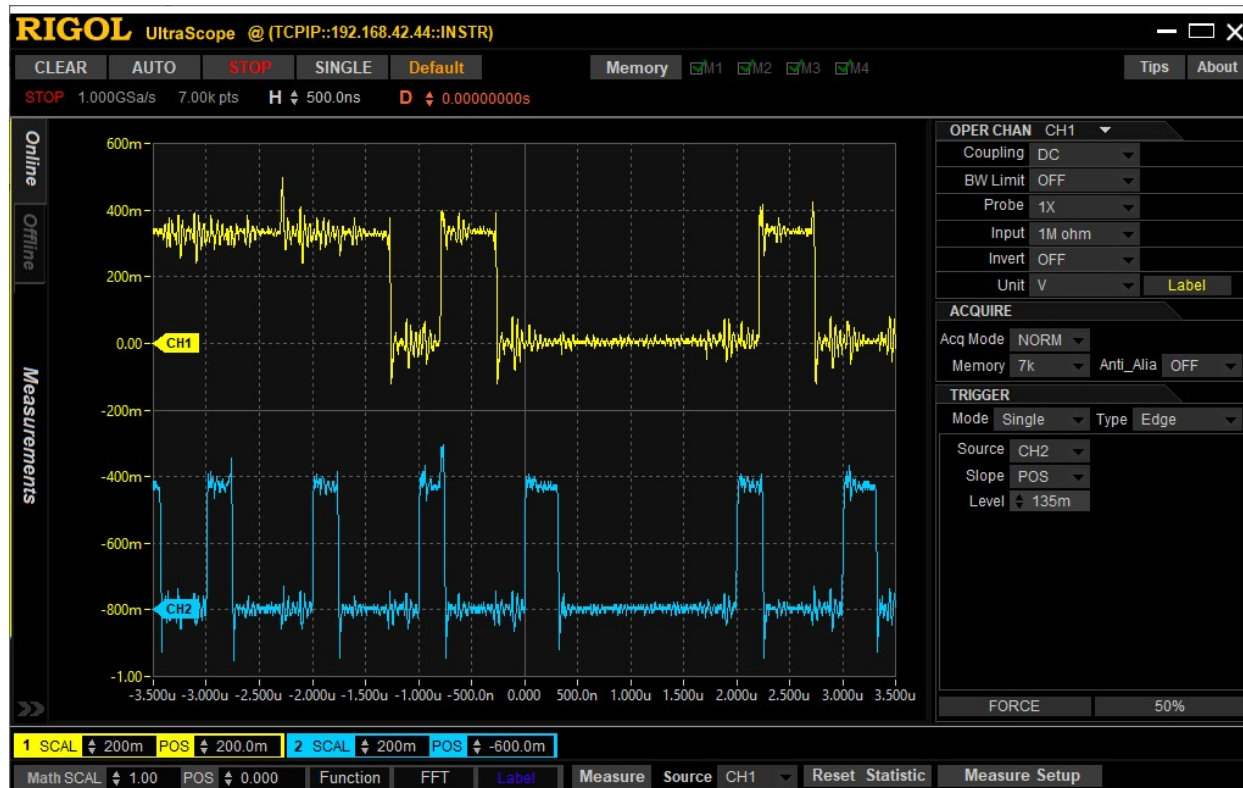
Here is a *typical* console input loop waveform using the ZPU without the PDP11V2 board. This waveform is taken at 4MHz to be consistent with the next one – but note that the earlier waveforms were taken at 2MHz. The ZPU is a good bit noisier than the newer Z80 board, below.

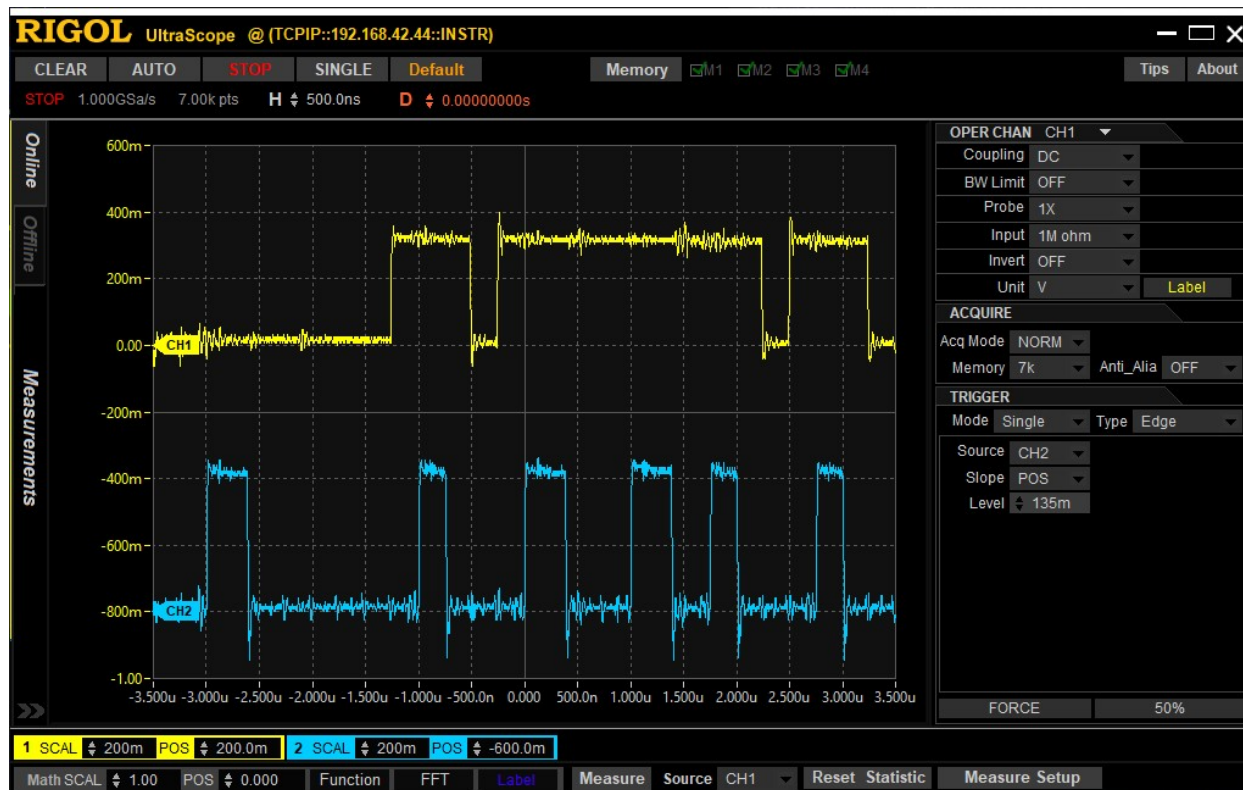
Here is a *typical* console input loop waveform using John Monohan's Z80 board, without the PDP11V2 board. Note that there is somewhat less noise on the address lines – but there is still some present, consistent with the observation that the false activation of the PDP11V2 board happens less often with this CPU board – but does still occur (though there is not any indication of spike on A3 sufficient to be a trigger.)

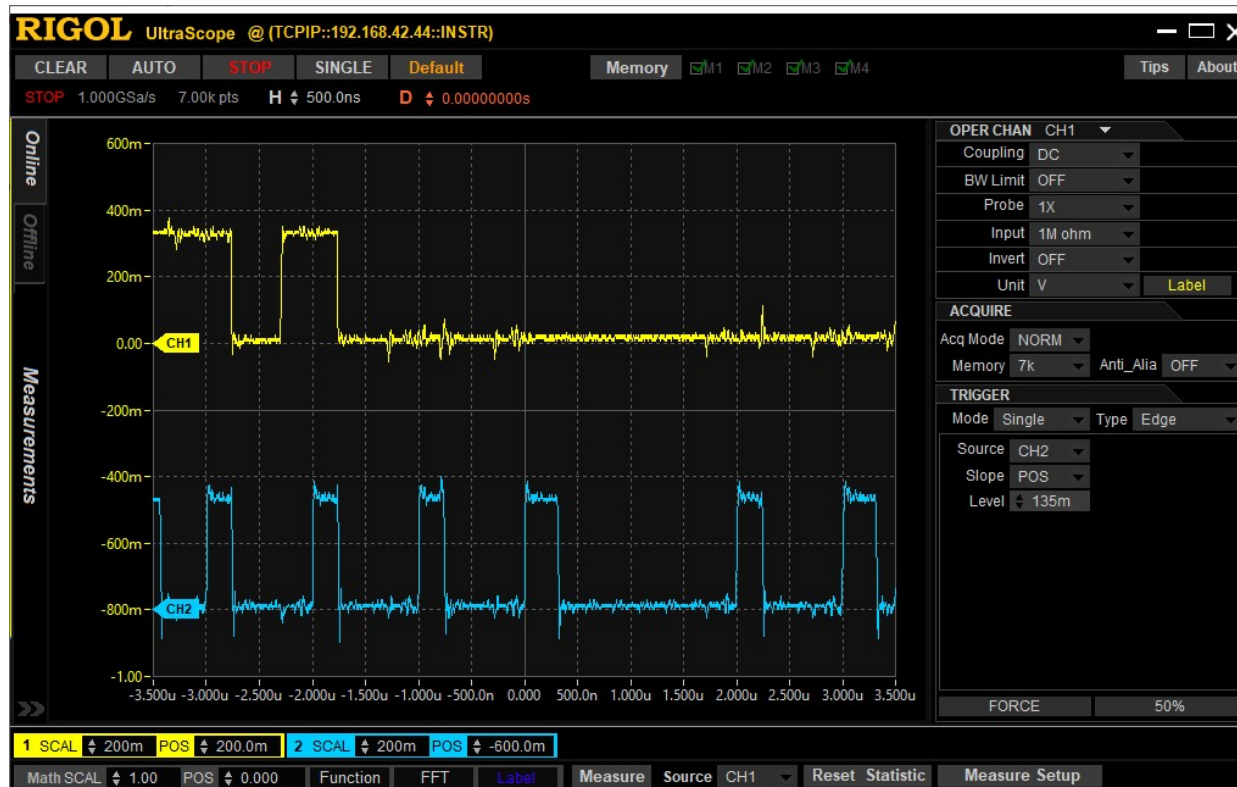
This picture is the *typical* console wait loop with the ZPU back in the system, and a Godbout active bus terminator at the end of the bus. There is considerably less noise, but the address line spikes are still present. (Especially notable is the one towards the right of the trace). Trigger is Ch2 (pDBIN)

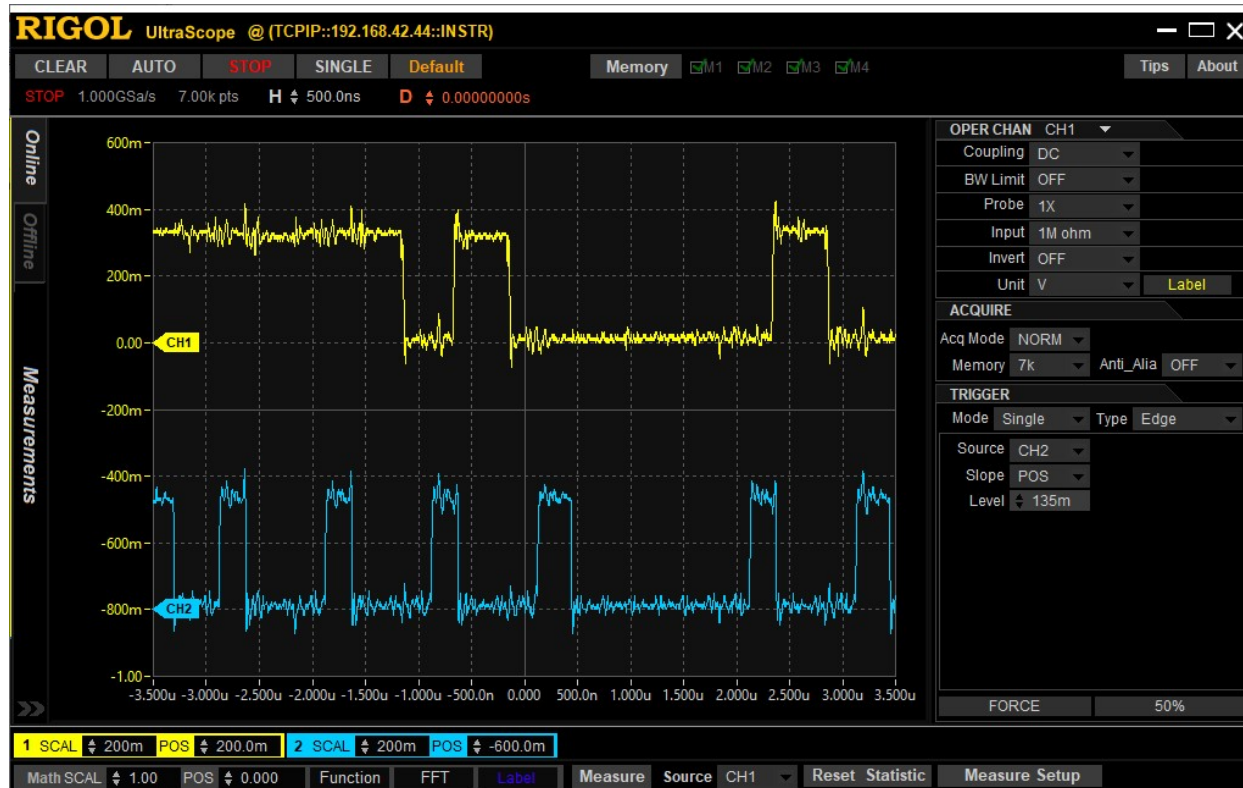
This picture of a *typical* console wait loop was taken with the PDP11V2 board back in place, the ZPU, with active termination. The noise on the address line is still apparent (note particularly the right hand side of the screen, where the spike occurs during the input cycle.) Trigger is pDBIN

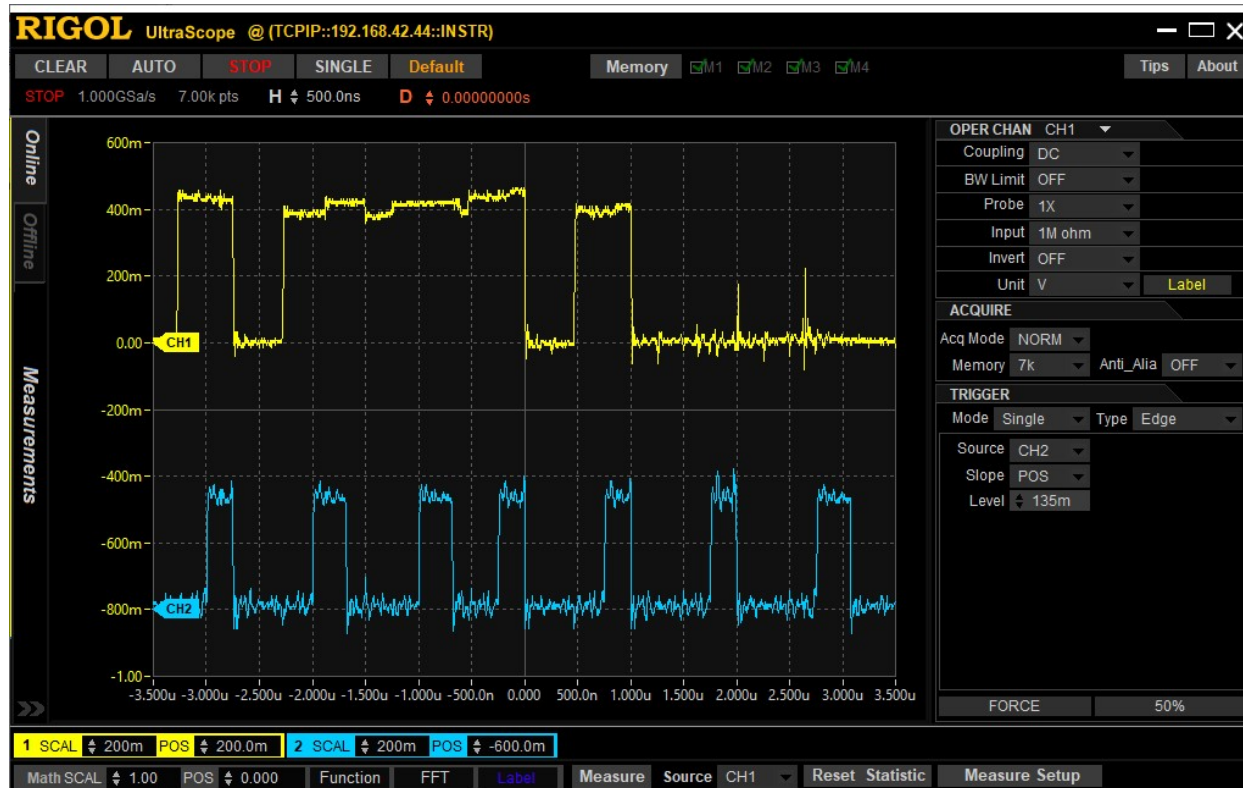
And here it is with the active terminator in place, with the ZPU at the output of the 74LS244, U30 (but not the same timing as above, of course), with the 2V+ spikes present. Trigger remains pDBIN.

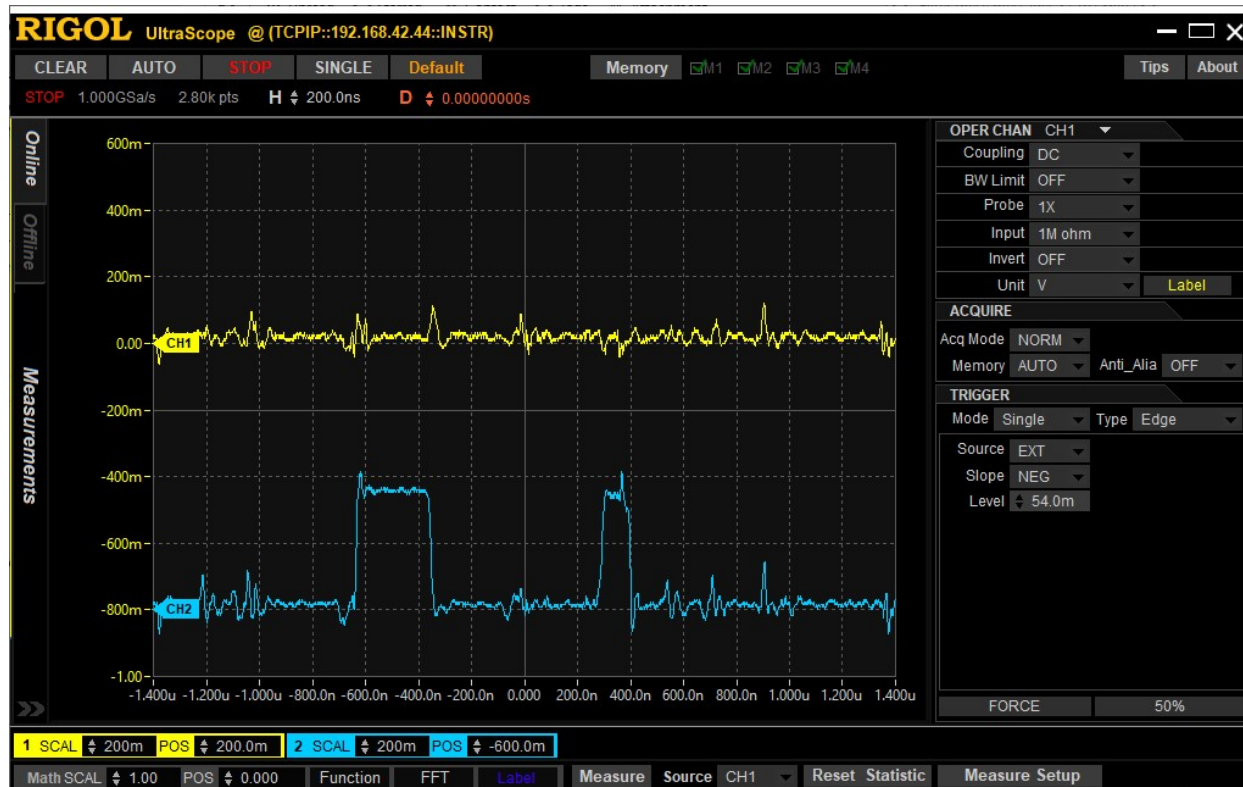
Finally, here is a trace with A3 and A11. My hope is that if I include some of the high order address lines in the equation (even though they should be the same as the low order address lines, as the ZPU board is jumpered to mirror I/O addresses) it will be less prone to the issue. (The trigger is back to TMAXPU).

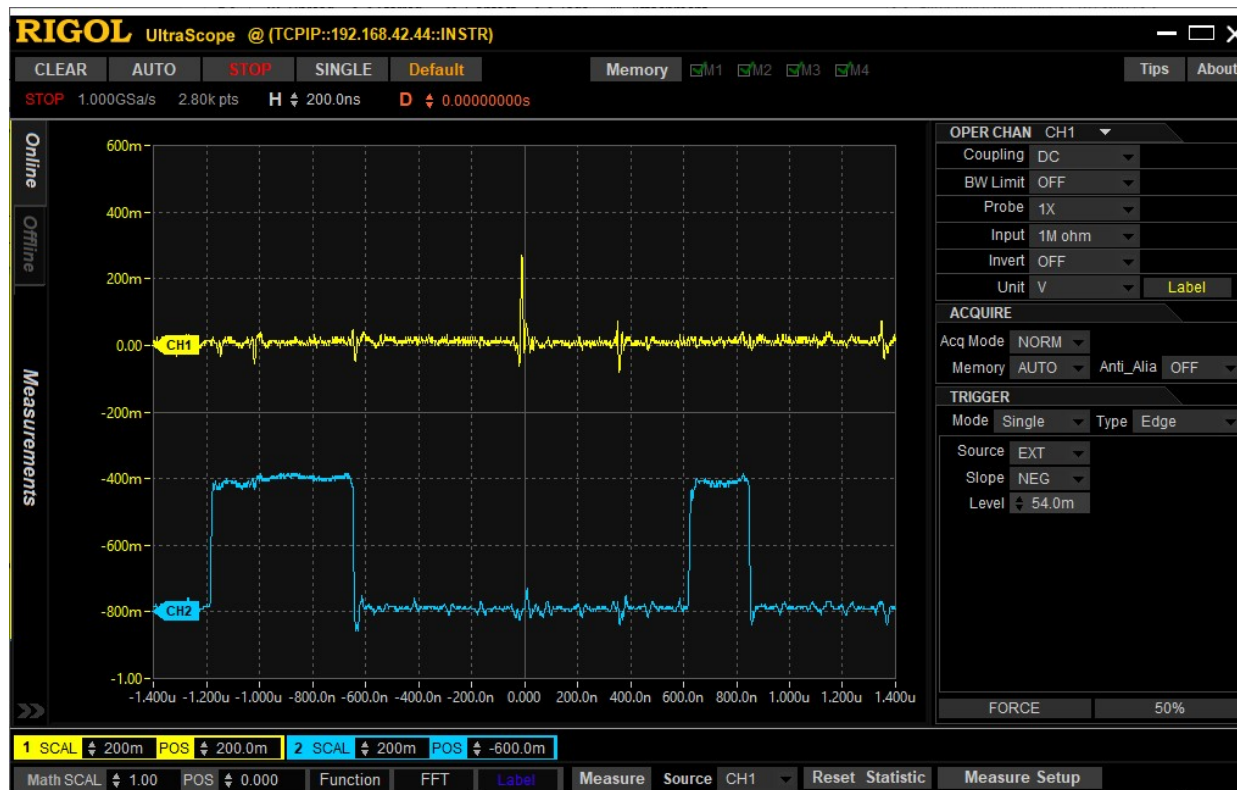
This trace, with the output of U30 pin 12 on CH1 (LA3) and U37 pin 12 on CH2 (LA11) shows that such an approach has some hope – and adds to the understanding of why I am having the issue and few/nobody else is. If the SMB is being used to activate TMAx, then this issue is not involved – the activation signal TMAx is driven by TMA0* or ... TMA3*. Secondly, if one is using all 16 bits (well, actually 13, since only A0 thru A12 are really in play), then this is much much less likely to occur. (Again, the trigger is TMAXPU). Had A11 been in the equation, this would not have triggered.

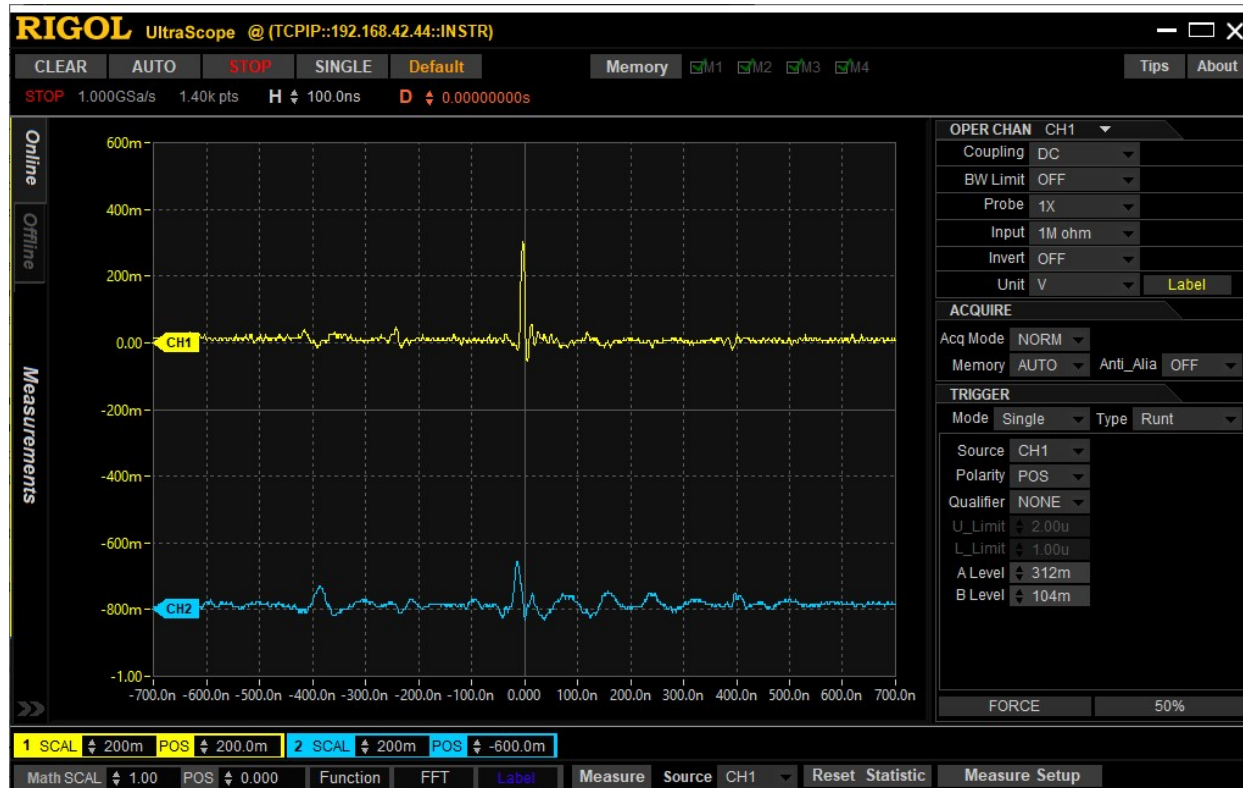
As a final check, I connected CH1 to the output of A3 on the 'LS244, and used the 'scope's "runt" trigger to capture the pulses (independently of TMAXPU), and displayed the input on CH2. (I also separately checked A11, and there were certainly times when A11 spiked as well.)

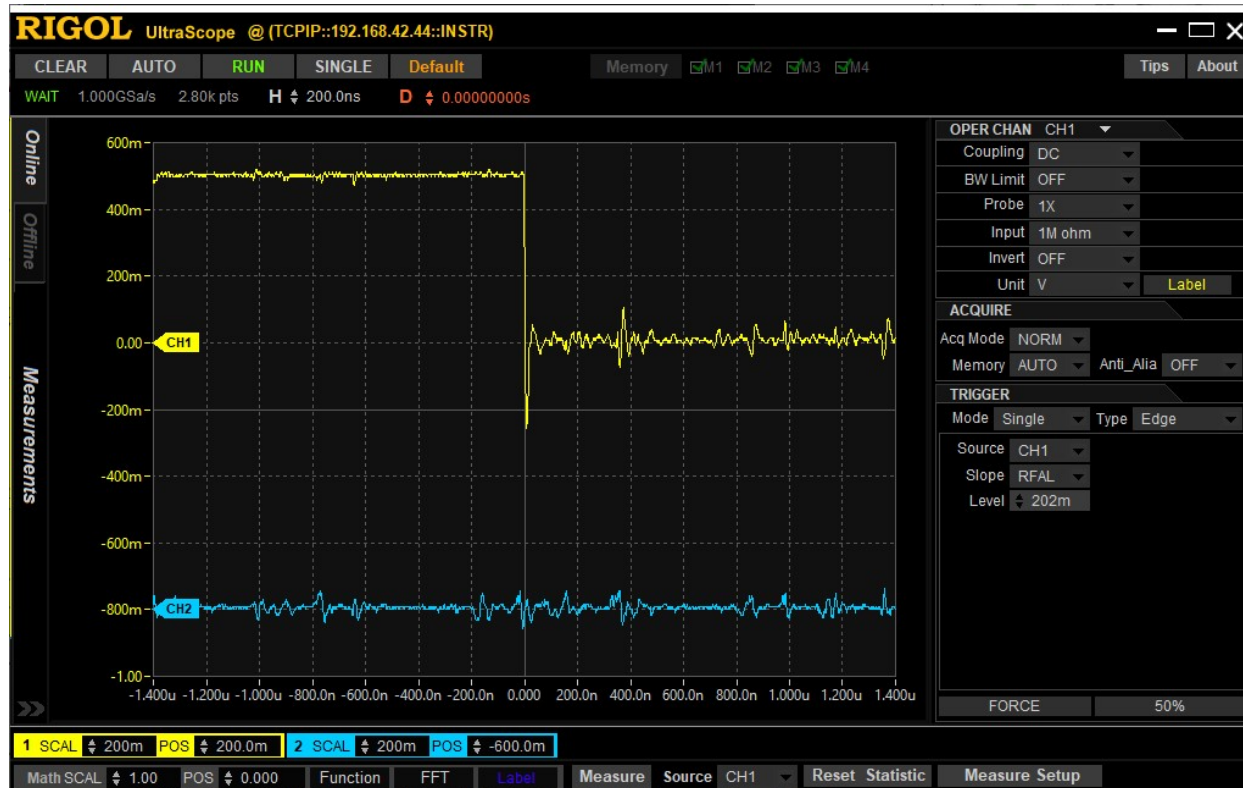
So, here is a trace of TMAXPU going active (low) during a “j0,efff” memory test. CH2 has sINP as it appears on the bus. This doesn’t even look like 0.8v to me (and it probably wasn’t).

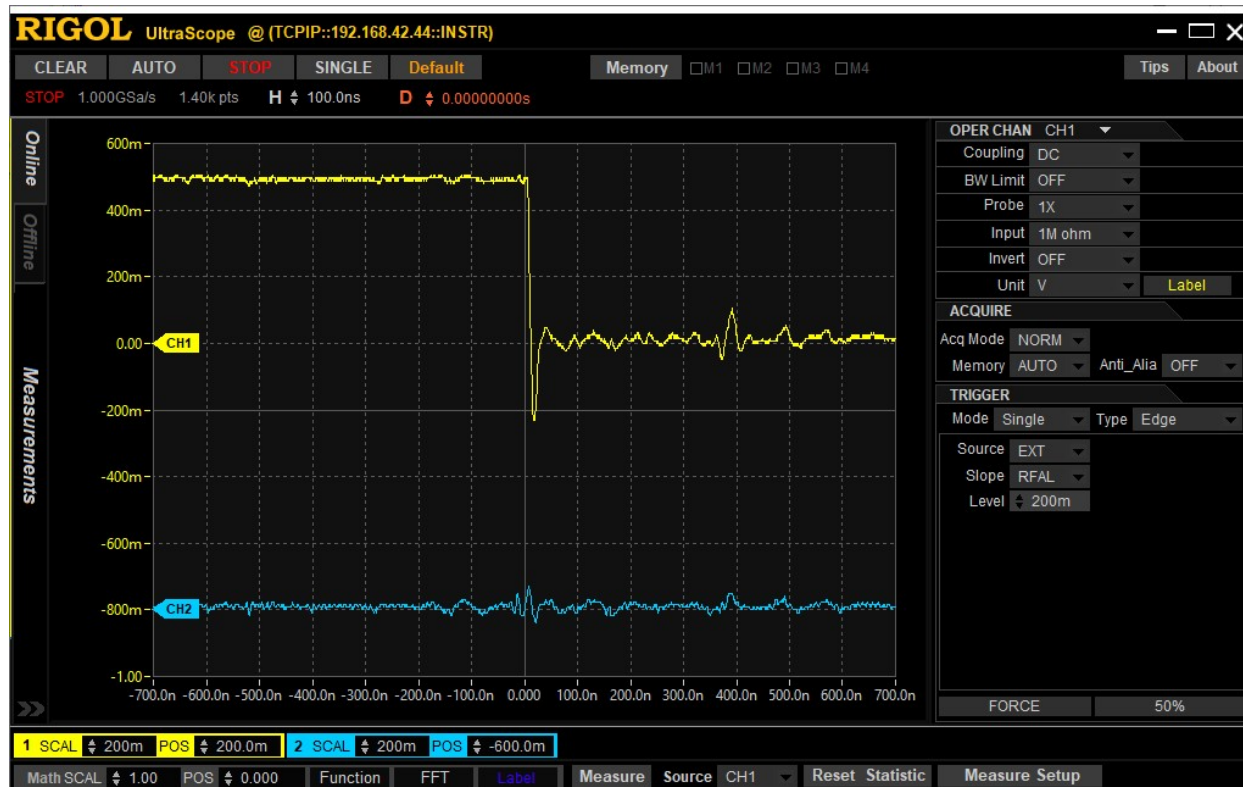
So, I then added a “probe point” on pin 8 of U21, the 74LS07 that generates the signal fed to U25. It (CH2) is just *barely* reaching into the 0.8v “no man’s land”. The CPLD is being very very touchy. Interestingly, the j0,eff command *does* do I/O – it checks for the operator pressing ESC to terminate the test. Curiously, if I put a probe point right on U25’s pin, the problem disappears completely.
