Setup: The jumper I normally have in place that connects TMAXPU to TMAx on the PDP11V2 card is removed – thus the card cannot actually request to be a bus master.

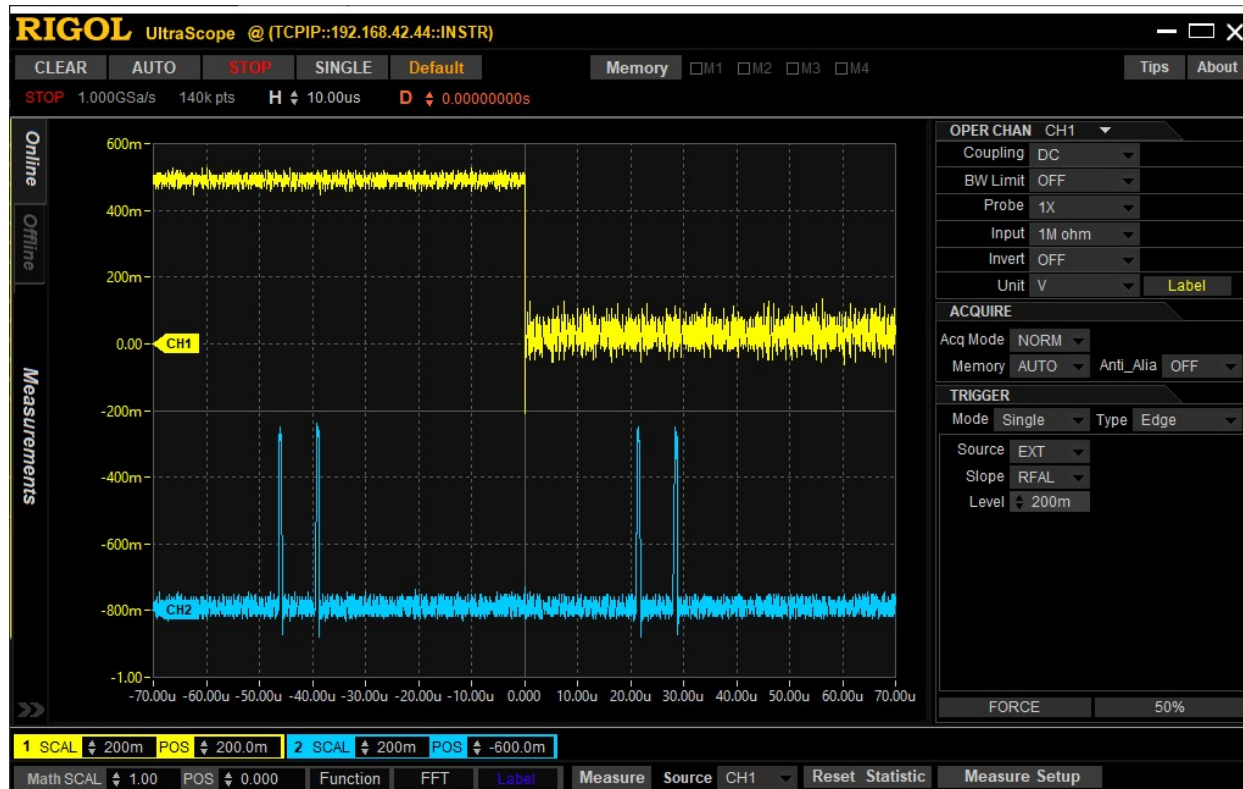
Interestingly, this issue seems to happen, when it happens, consistently a bit under 40us after the last real I/O (an eternity, really) (and not at any consistent point in the test itself)

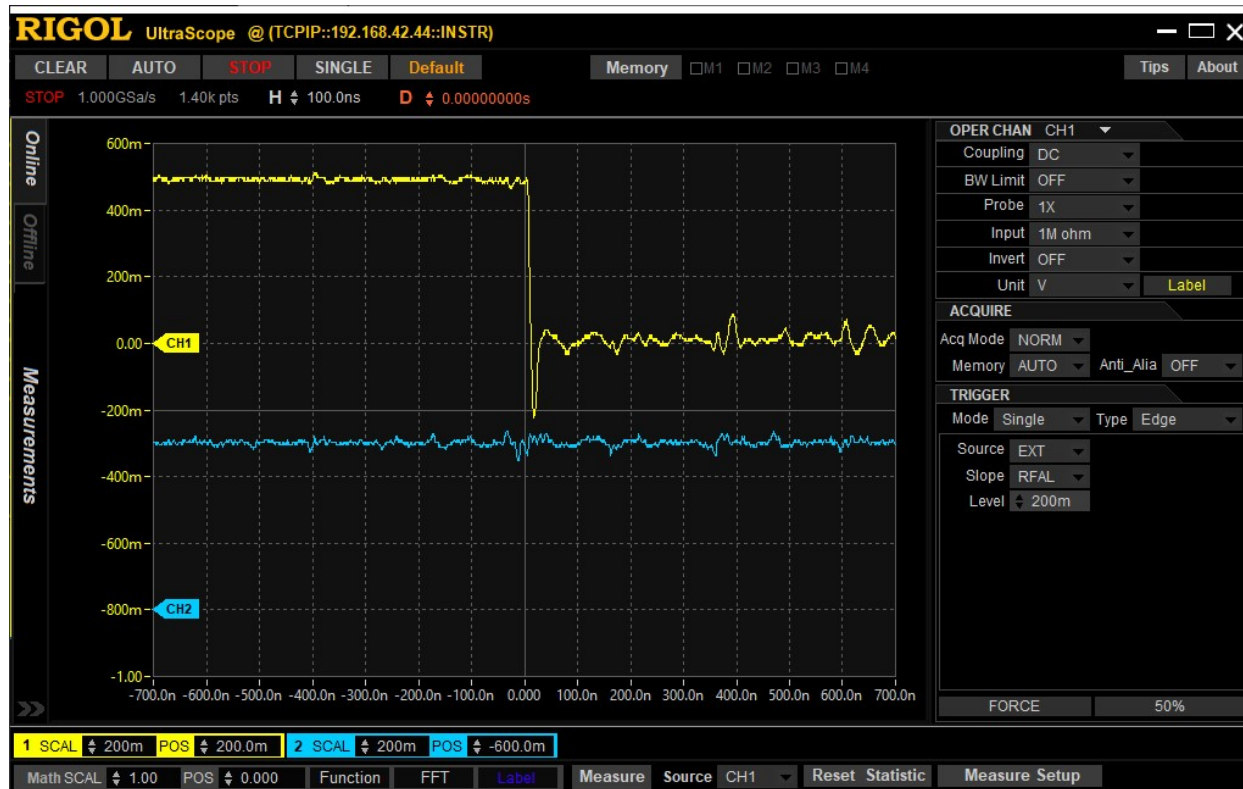
This made me a little suspicious. Could this be a noise immunity issue caused by noise on the +5V rail? So, I 'scoped the rail (with a probe point right at one of U25's bypass capacitors) during this new issue. Note the dip, of about 0.5v, right when this happens.

So, I paralleled the 0.1uF caps on the back side, but that did help. Neither did 10uF. Nor did a .01uF. The 8v line also has a corresponding drop. The drop is about 10ns long (so, about 100MHz), so no wonder adding 10uF did not make any difference. Later I tried adding .0047 and an additional 10uF at the regulator. That actually turned it into a little positive going bump – but the board still activated.

PostScript: This issue went away when I removed the Godbout active terminator.

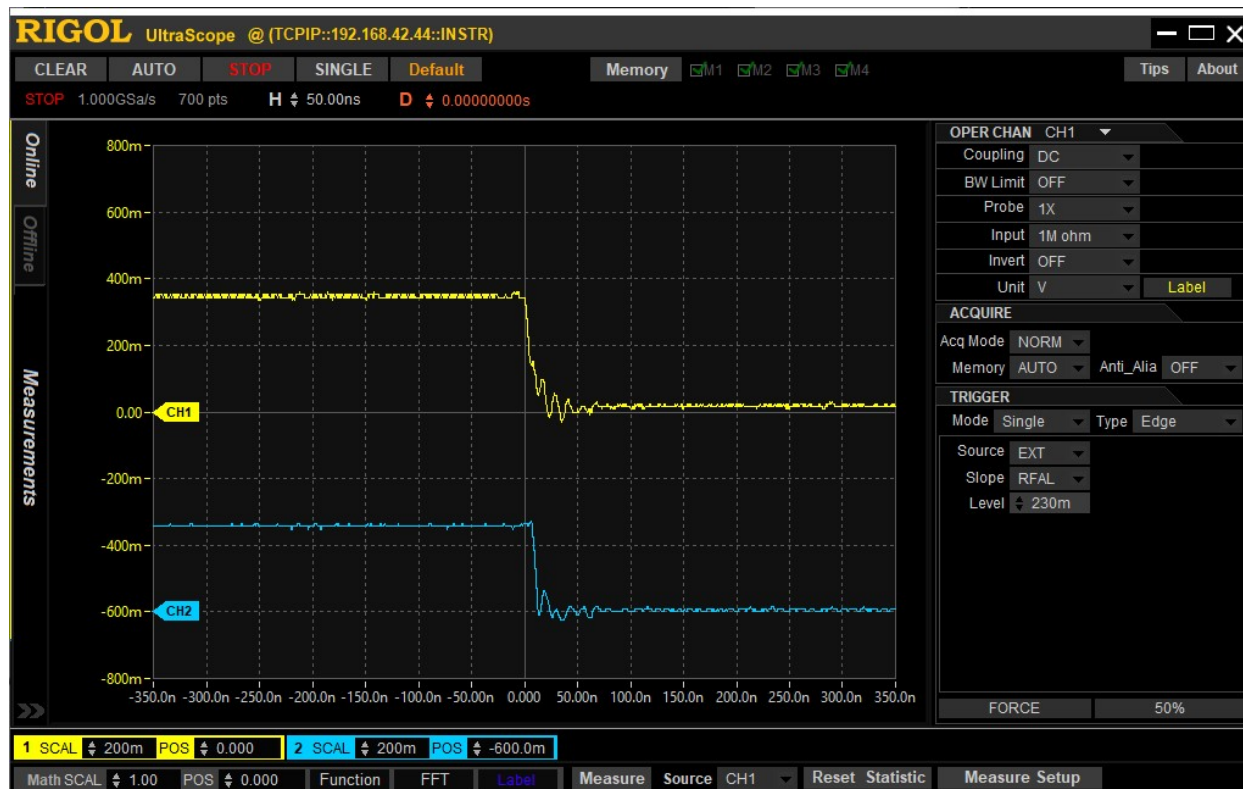
Here is a screenshot with the active terminator in place. The trigger is D* brought out to P26 on PDP11V2 U15 – so any odd byte write. I then entered a BOE001,41 command to the PDP11V2 monitor, running on the UART. The top signal, CH1, is pWR* on the S100 bus. The bottom signal is D2 sampled at PDP11V2 U20 pin 13. Note that the pWR* is going (or at least starting to go) active low well BEFORE the data line reaches its desired state. The horizontal is 50ns/div, so it is maybe 50ns to 60ns early. Note that the baseline for the data in high impedance state is on the order of 2.6v where it should be with the active terminator in place.

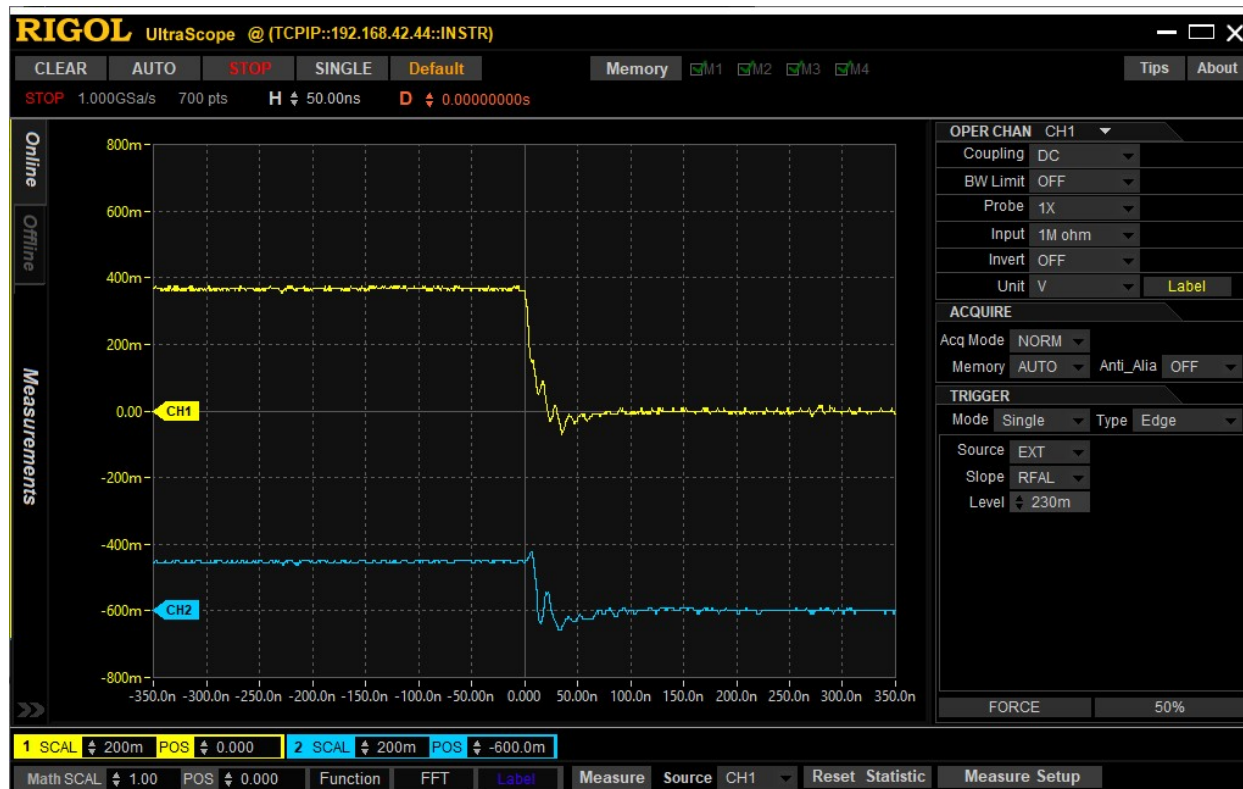
Here is the same setup, but with the active terminator removed. In this situation the correct output is observed, but that is likely simply because the data waveform has a baseline starting at 1.6v – closer to 0. pWR* still has not given the data time to stabilize. It probably works only because of a couple of gate delays on the Propeller board give it just enough time.

This is not conformal. The IEEE 696 spec for a write cycle specifies a tDWR time (setup time DO valid BEFORE pWR* goes low) of 0.1tCY. tCY is one system clock cycle. At 4Mhz that would mean that the data should be stable for at least $0.1 * 250\text{ns}$, or 25ns, BEFORE pWR* goes low.

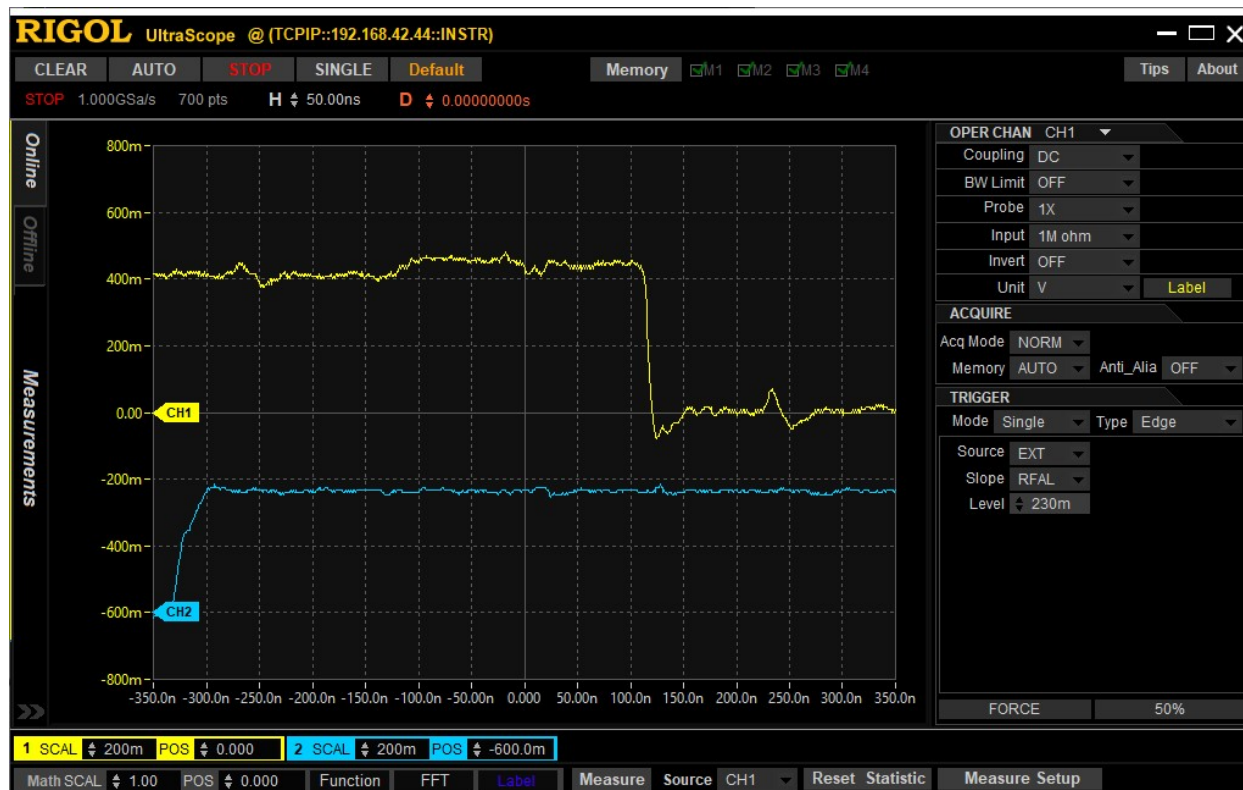
Finally, here is a picture of the Z80 outputting to the same port (the character is "A") (CH2). CH1 is the pWR* signal for the I/O (pin 77). It comes slightly after the trigger, which is sOUT (pin 45).

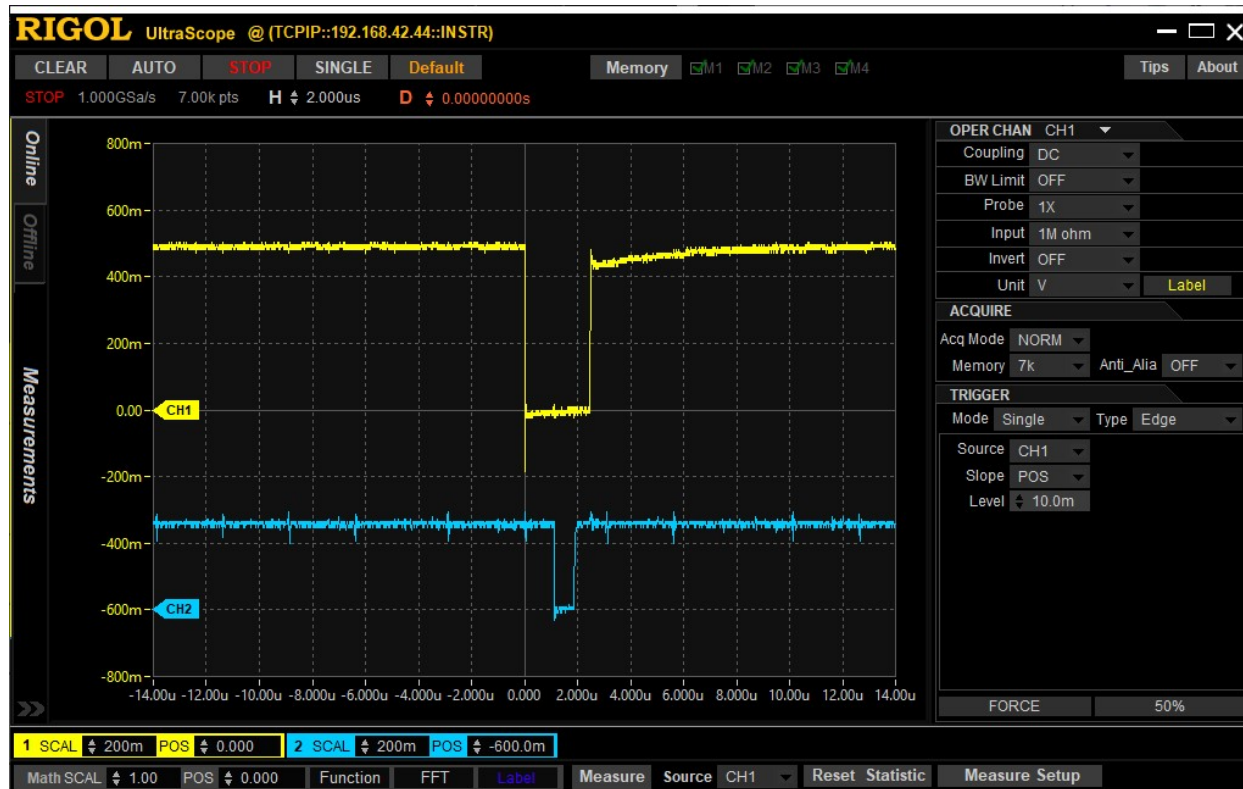
The idea I had is to remove the signal $bpWR^*$ from the equation for OE_C, OE_D and OE_B. Here is a trace of what that would look like. CH1 (and the trigger) is the proposed new signal. CH2 is the output data – plenty of setup time.

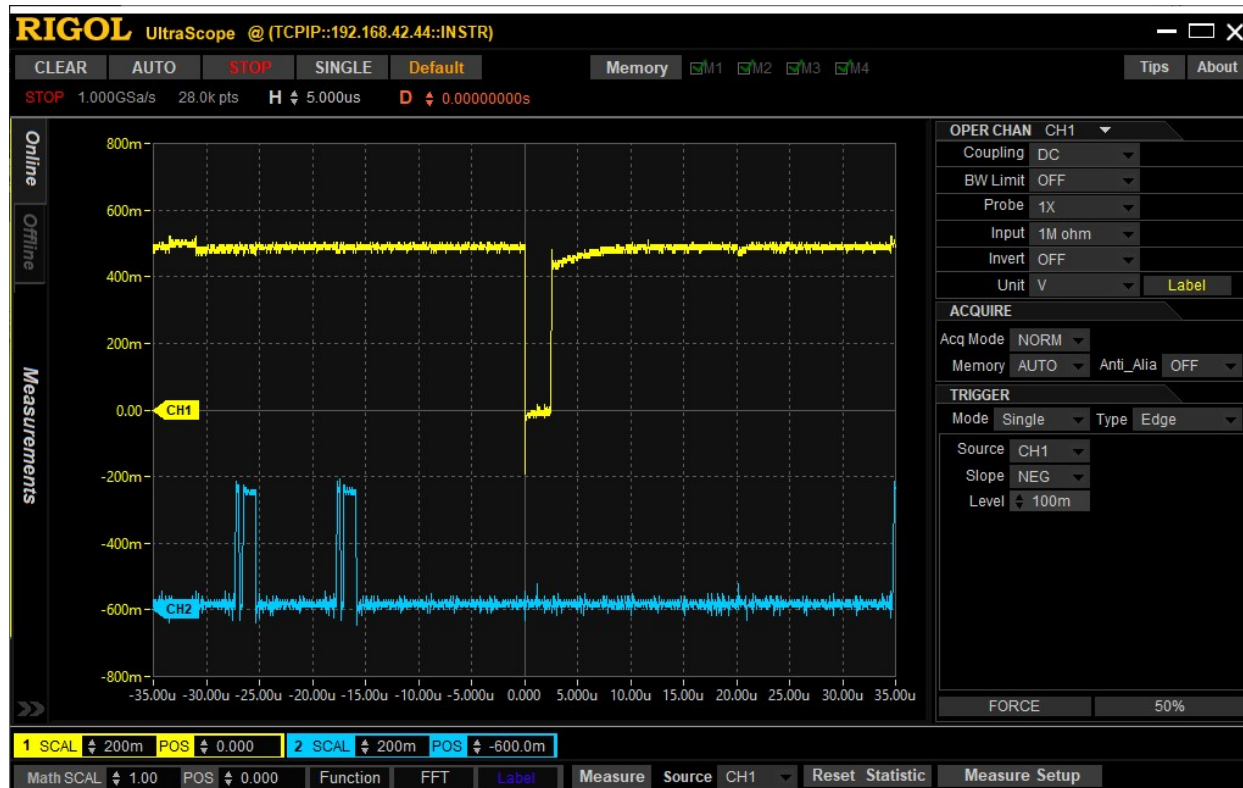
And here is the new signal compared to pDBIN (CH2). It shows no danger at all of this new signal causing bus contention by overlapping with pDBIN.

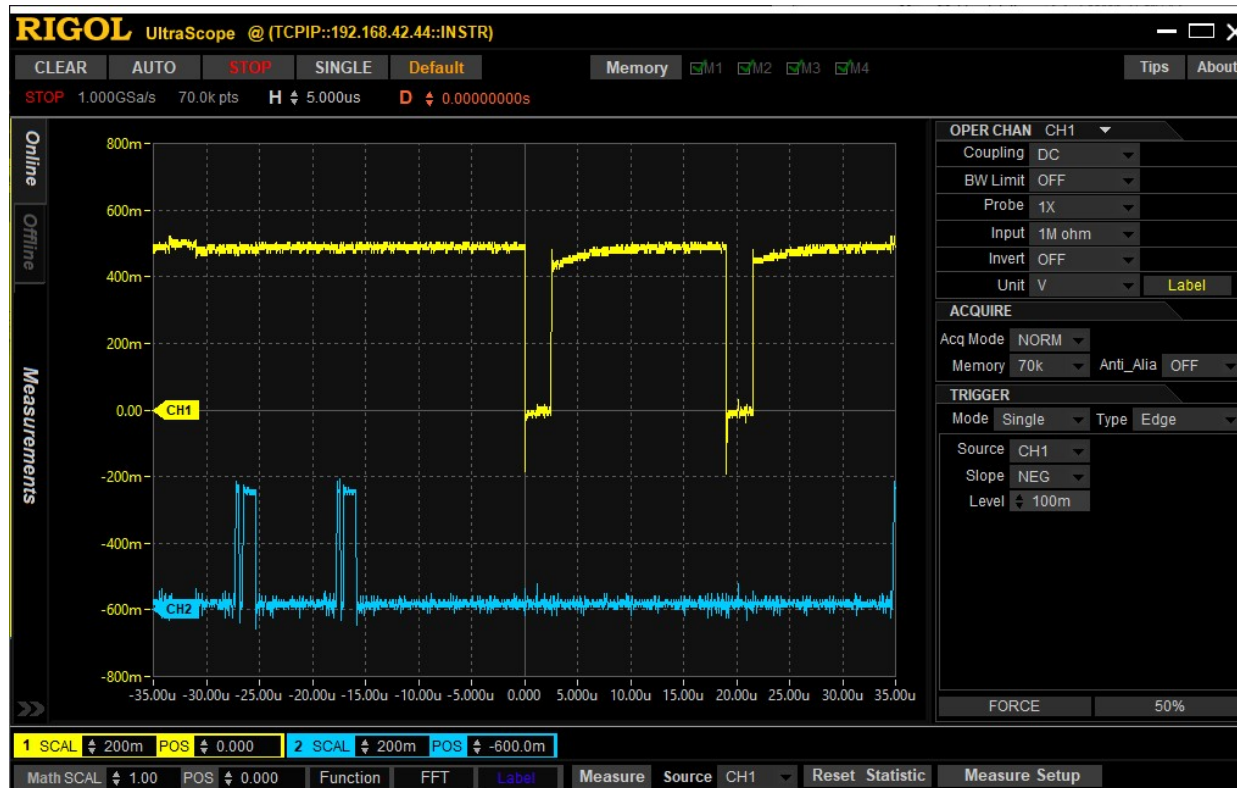
I then changed the test signal to enable the new scheme for both byte and word/even writes. This trace shows the new signal on CH1 compared to pDBIN:

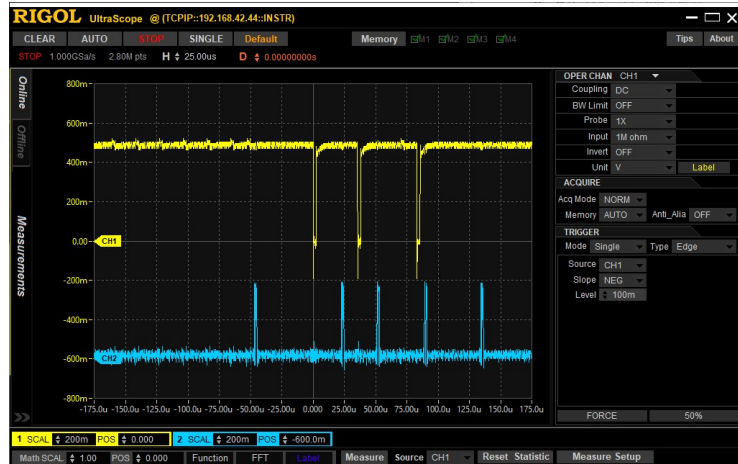
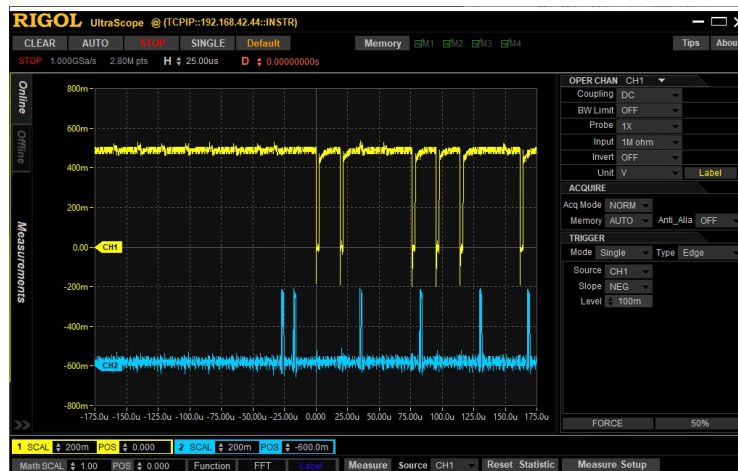
Here are a couple of traces on a much longer timebase (25us). The first was at a different spot in the code. The second is from the output to E001. There is clearly no danger of overlap between enabling the PDP11 output buffers (active low, CH1, also the trigger) and pDBIN (active high, CH2).

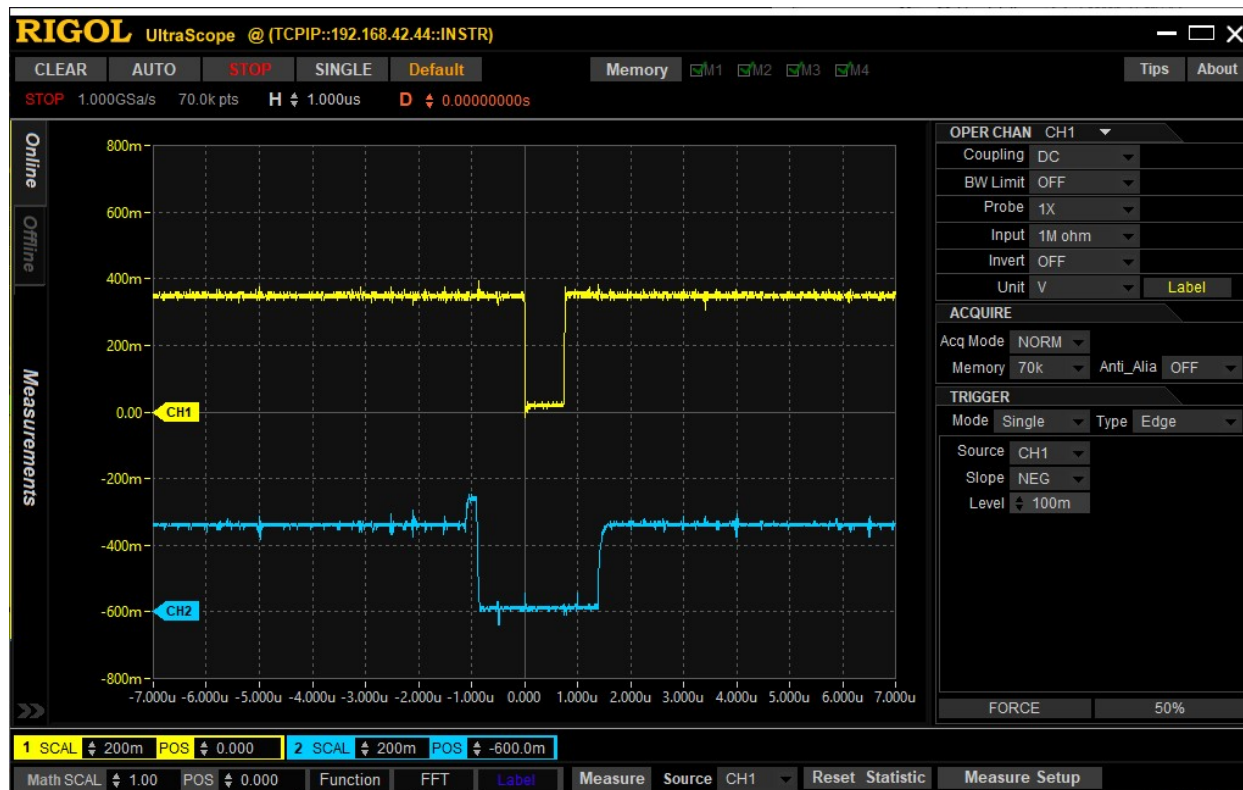
I then removed the term I_{bpWR} from the equations for I_{OE_C} , I_{OE_D} and I_{OE_B} (it was not present for I_{OE_A} , which is a read cycle). I have not removed it from I_{bsXTRQ} . Here is what it looked like. CH1 is $S100\text{ pWR}^*$ and CH2 is the data on pin13 of U20. Note the little positive excursion that happens in the data initially. That matters not at all – it is during the time when the data has not yet been set up by the J11:

And, indeed, the correct output is observed.

```
!OE_C      = ((( /* !bpWR & */ !BUS_WORD_WRITE & !XFERII & !bsINTA) # (bpDBIN & !XFERII & !bsINTA)) /* U17, 16 Bit Rd or /Wr and  
8 bit Rd, DAL 8-15 */
```

```
!OE_D      = /* !bpWR & */ !BUS_BYTE_WRITE & LA0 & !XFERII & !bsINTA; /* U20, 8 Bit Write Odd address on DAL 8-15 */
```

```
!OE_B      = ((( /* !bpWR & */ !BUS_WORD_WRITE & !XFERII & !bsINTA) # (bpDBIN & !XFERII & !bsINTA & !SIXTN)) /* U23, 16 Bit Rd or  
Wr and 8 bit (RAM) Rd */
```

```
# ( /* !bpWR & */ !BUS_BYTE_WRITE & !LA0 & !XFERII & !bsINTA)); /* 8 Bit Write Even address (DAL 0-7) */
```

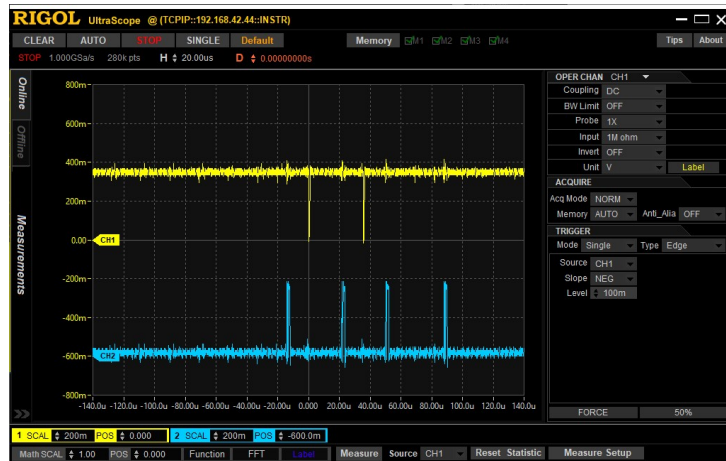
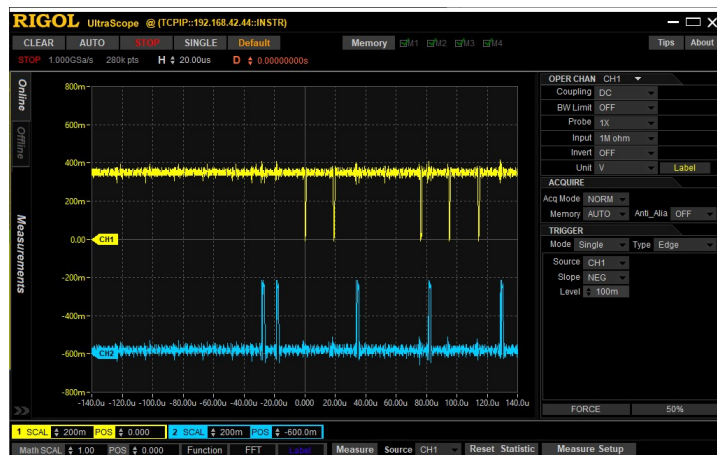
Here are pWRT* and pDBIN on a much longer time scale. As before, the first trace is while entering “BOE001,41” (but before hitting Enter), and the second is upon pressing Enter. Several machine cycles are shown, clearly illustrating no danger of conflict on the bus for the data lines:
